CANYON LEGACY

THE 1983 FLOOD

How the Glen Canyon Dam held up
under the impact of cavitation

by John Keys,
Former Commissioner
U.S. Bureau of Reclamation

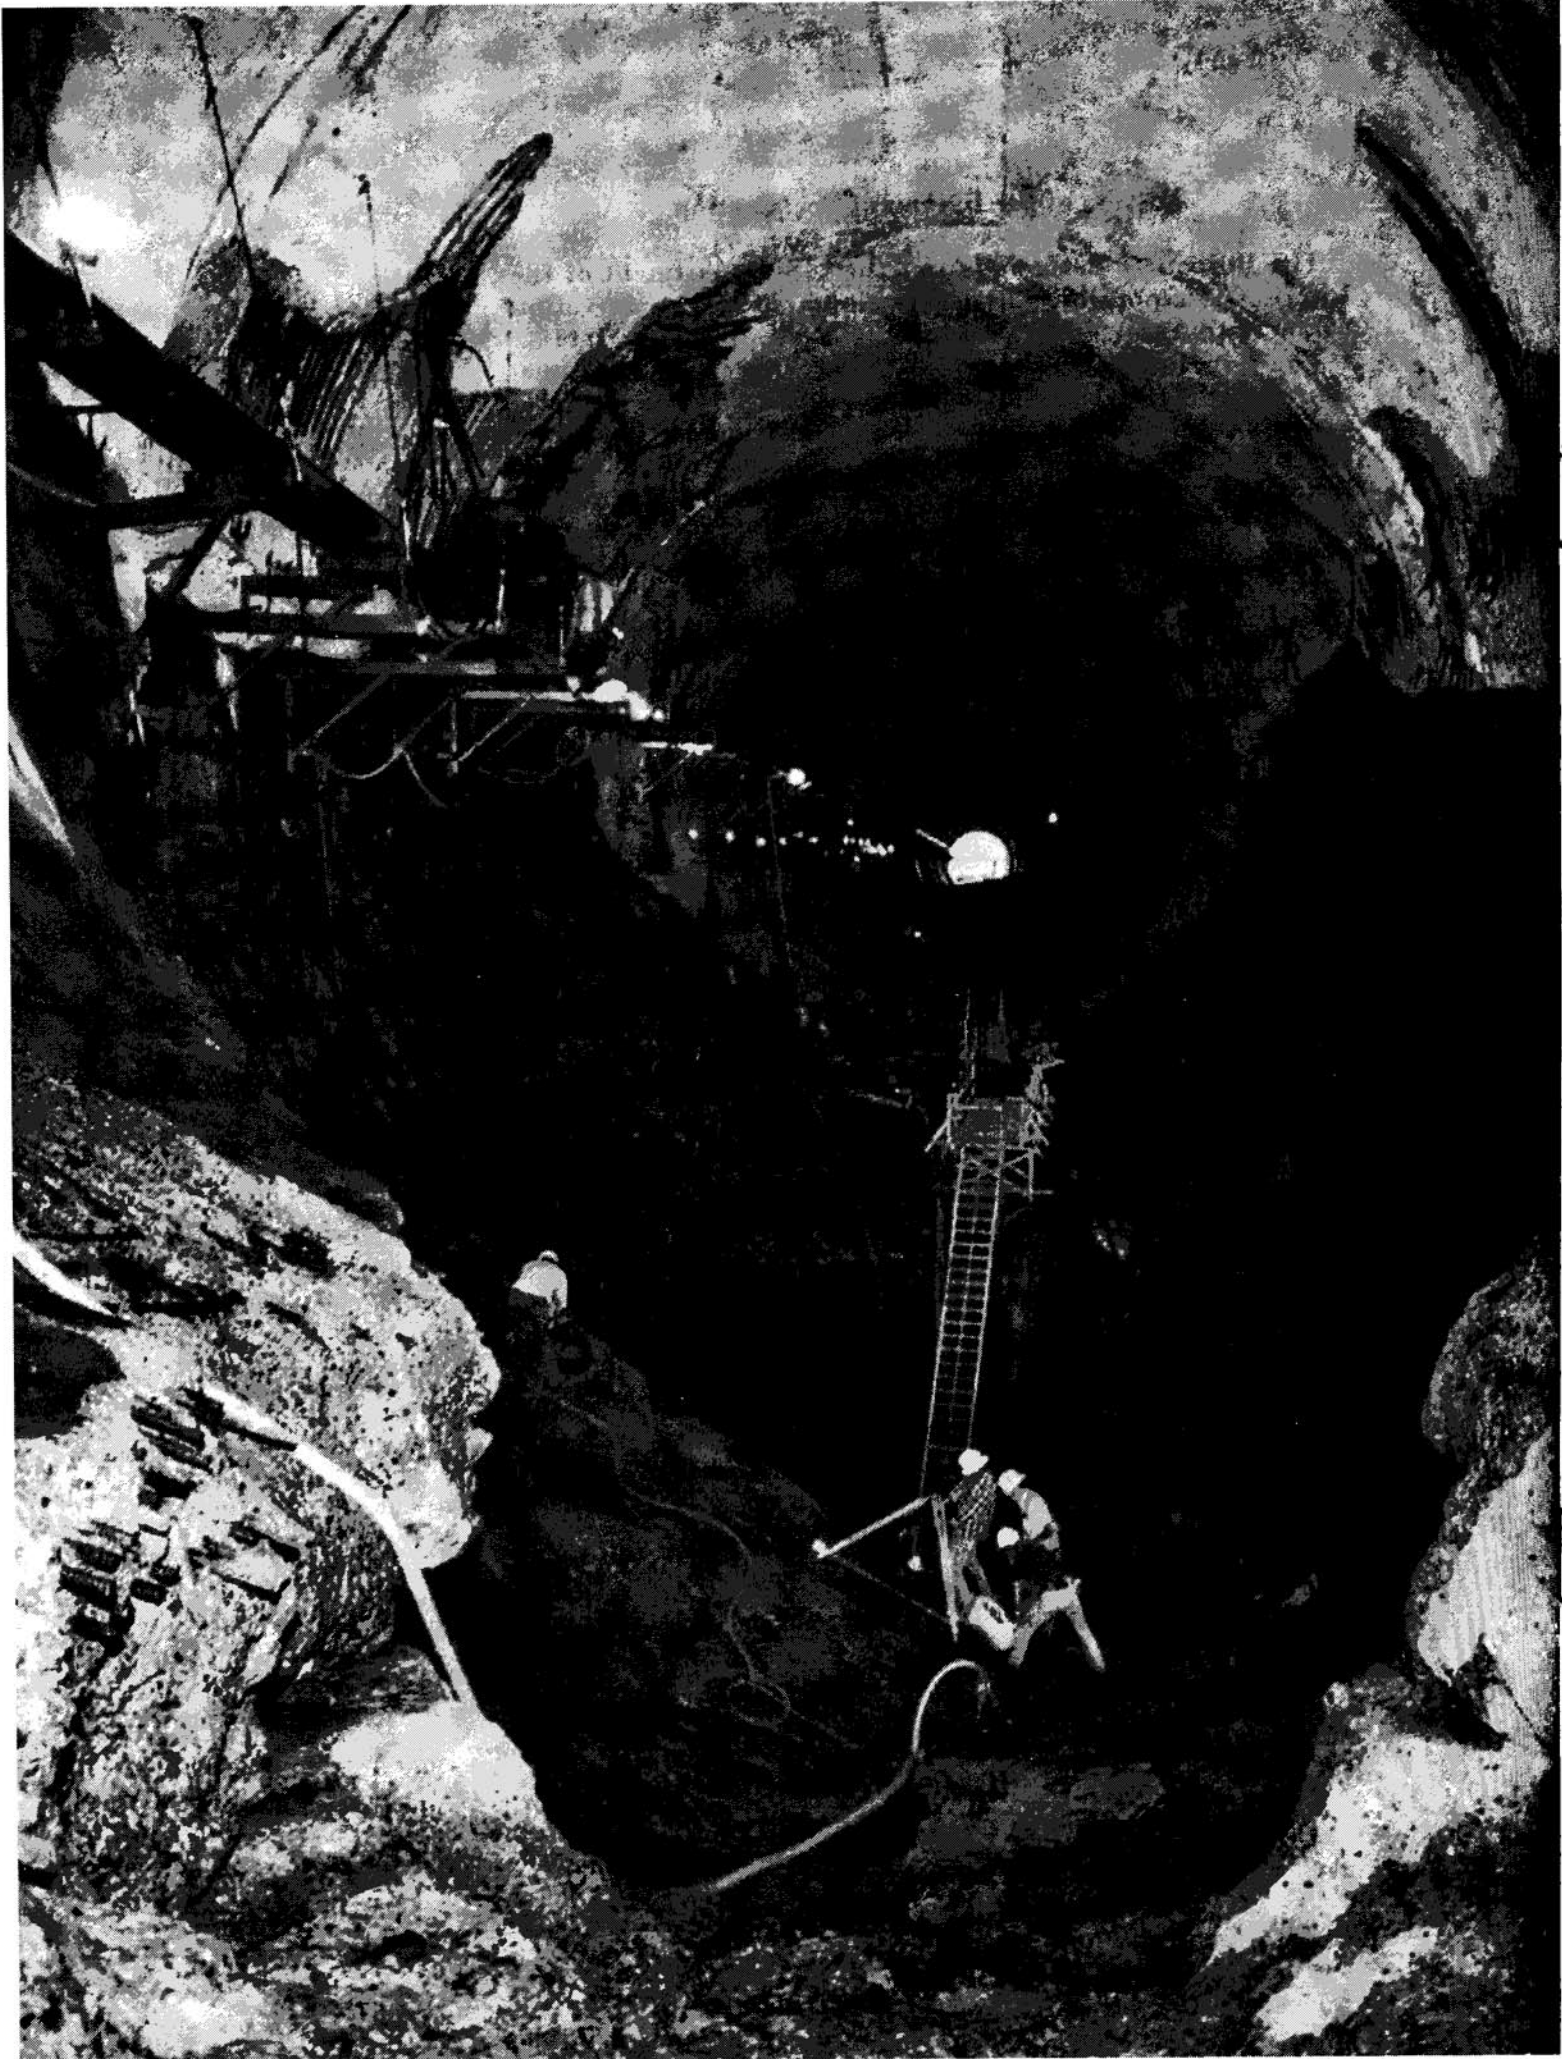
The picture at left was taken of Glen Canyon Dam in 1983. Photograph courtesy the U.S. Department of Interior, Bureau of Reclamation, Upper Colorado Region. Photo by Joe Dahilig.
